## The effectiveness of patch repairs to restore the impact properties of carbon-fibre reinforced-plastic composites

Z.E.C. Hall<sup>a,\*</sup>, J. Liu<sup>a</sup>, R.A. Brooks<sup>a</sup>, H. Liu<sup>a,\*</sup>, J.W.M. Crocker<sup>a</sup>, A.M. Joesbury<sup>b</sup>,  
L.T. Harper<sup>b</sup>, B.R.K. Blackman<sup>a</sup>, A.J. Kinloch<sup>a</sup>, J.P. Dear<sup>a,\*</sup>

The present paper studies the low-velocity impact testing of carbon-fibre reinforced-plastic (CFRP) pristine and patch-repair CFRP panels. Firstly, the effect of repeated impacts on the pristine CFRP damage growth is considered at impact energies of 7.5, 10.5 and 30 J. Secondly, such tests lead to a single-sided, patch-repair panel being manufactured by removing a 40 mm diameter central hole, to act as the 'damaged area', from the parent CFRP panel and then adhesively-bonding a circular CFRP patch-repair over the hole so generated. Various diameters and thicknesses for the CFRP patch-repair are employed and, in some cases, a CFRP circular plug is also used to fill the hole created by removal of the parent composite. The measured load versus time, and load versus displacement, traces are compared. Further, the ex

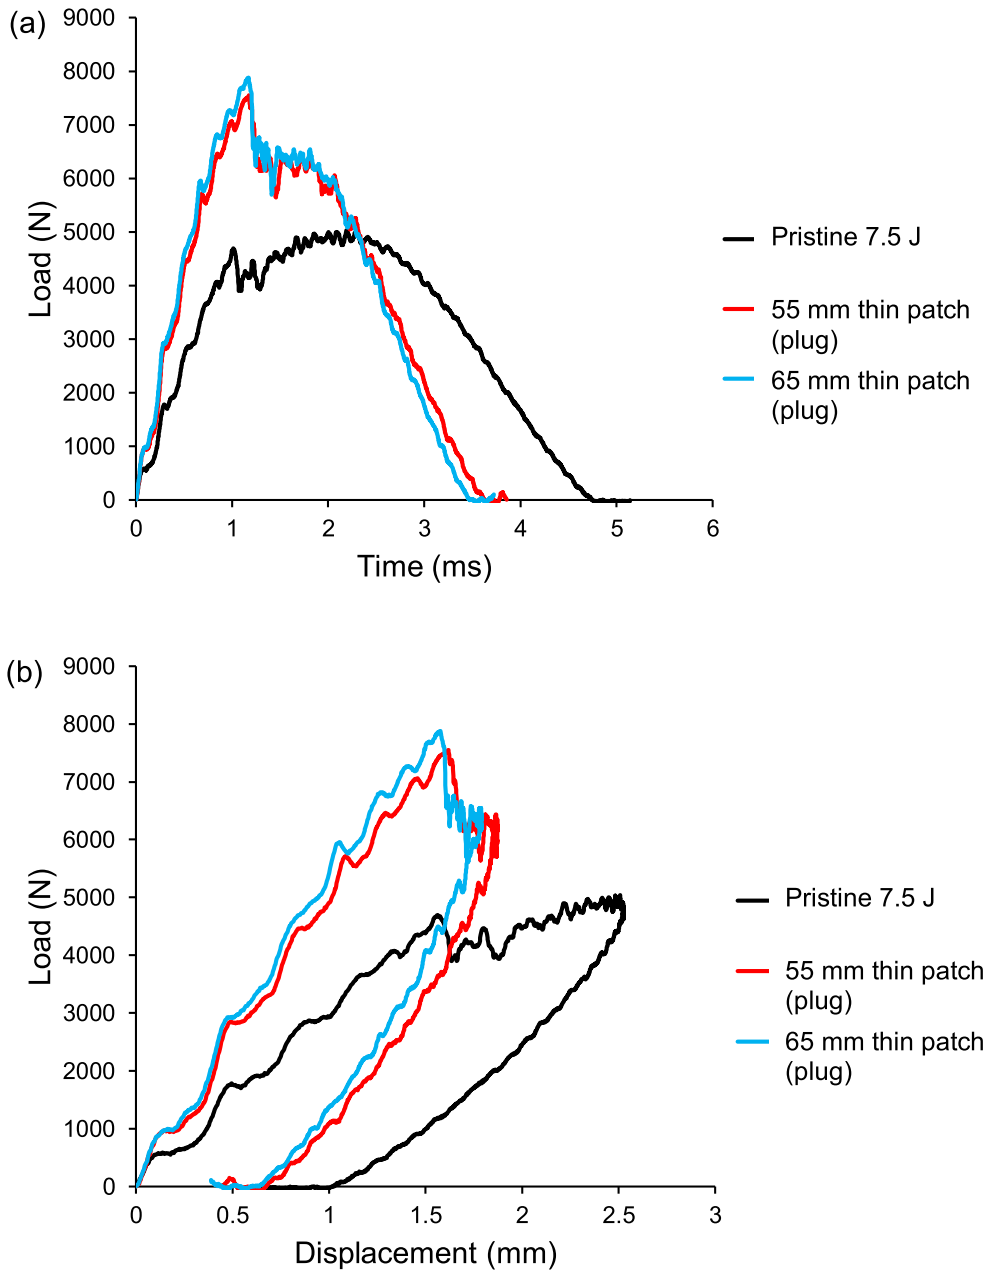
**Fig. 9.** Load traces for a pristine CFRP panel and 55 mm diameter and 65 mm patch-repair panels, with a CFRP plug, impacted at 7.5 J. The thickness,  $t$ , of the parent and the plug CFRP was 4.58 mm and the thickness,  $0.5 t$ , of the patch was 2.29 mm. Shown are the: (a) load versus time traces and (b) load versus displacement traces.

Four repair panels with CFRP plugs were manufactured in total: two for each patch diameter, i.e. 55 mm and 65 mm, with a patch thickness, 0.5 t, of 2.29 mm. For these patch-repair panels with a plug present, the load versus time, and load versus displacement traces are compared to the performance of the pristine CFRP panel in Fig. 9 for an impact energy of 7.5 J. From these traces, it can be seen that the overall stiffness of the panel and the initial damage load are increased, and the maximum displacement is reduced, when a repair is undertaken using a plug. This is mainly due to the increase in the overall thickness that the patch and plug together add to the patch-repaired CFRP parent panel, compared to that of the pristine CFRP panel. However, there is a more sudden drop in the load after damage initiation in the repaired panel compared to the pristine panel, which could be due to the overall increased stiffness of the

A notable point about Fig. 9 is that the load versus time, and load versus displacement, traces for the patch-repair panels with a plug have a higher maximum load of just under 7880 N, at a time of approximately 1.2 ms, for the 65 mm diameter patch and 7550 N, at a time of approximately 1.2 ms, for the 55 mm diameter patch, compared to the pristine CFRP panel. In both cases, there is a significant load drop, indicative of damage initiation. Thus, an increase in patch diameter to 65 mm is somewhat beneficial in raising this initiation load from 7550 to 7880 N, as would be expected. Furthermore, these initiation loads are indeed much higher than for a pristine panel, i.e. 4693 N at 1 ms. For all these patch-repair panels with a plug, as for the pristine panel on first impact, there are slight oscillations in the load up to the maximum value due to mass-spring oscillations. Clearly, adding a patch of thickness,  $0.5 t$ , of 2.29 mm, together with a CFRP plug, of thickness,  $t$ , of 4.58 mm, is very beneficial in restoring the overall structural response of the parent CFRP composite, of thickness,  $t$ , of 4.58 mm, and this is evident by the increase in the initiation load and the stiffness for the patch-repair CFRP panels with a plug.

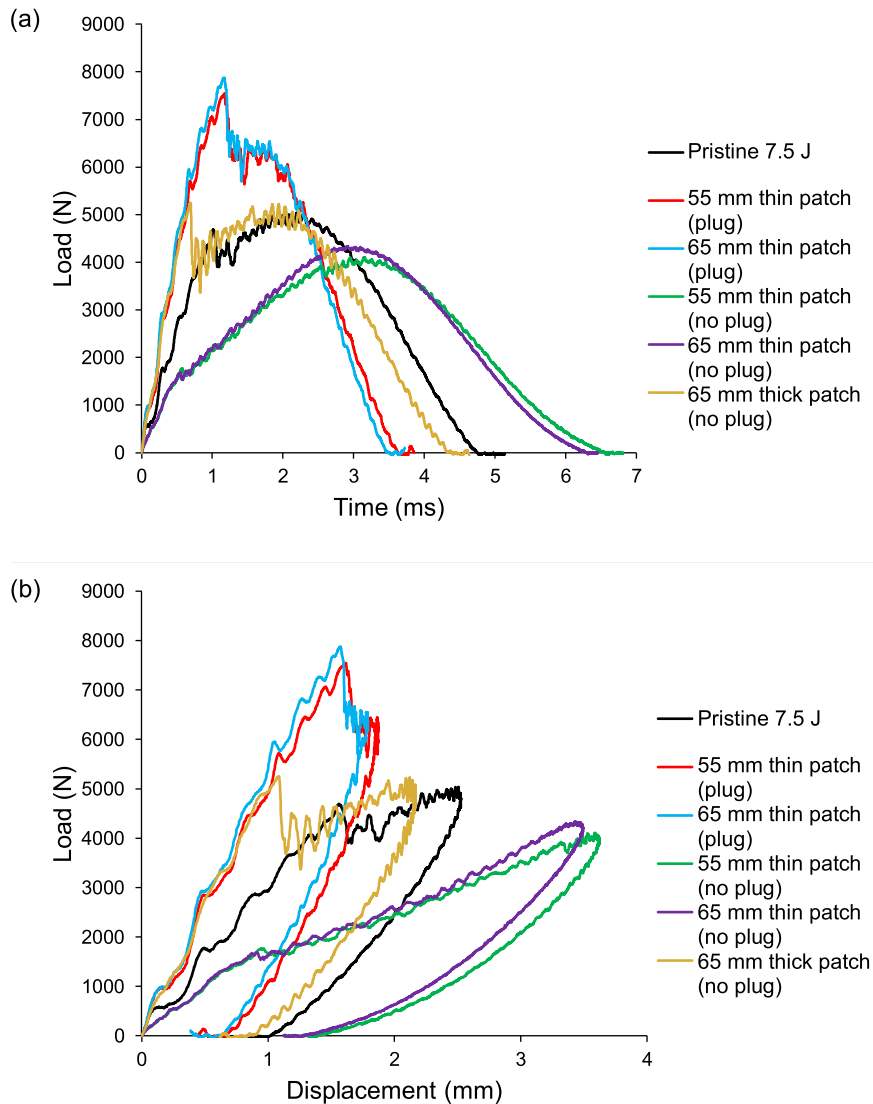
**Fig. 16.** Load traces for the pristine panel, the 55 mm diameter thin ( $0.5 t = 2.29$  mm) patch-repair panel with a plug, the 65 mm diameter thin ( $0.5 t = 2.29$  mm) patch-repair panel with a plug, the 55 mm thin ( $t = 2.29$  mm) patch-repair panel with no plug, the 65 mm thin ( $0.5 t = 2.29$  mm) patch-repair panel with no plug and the 65 mm thick ( $t = 4.58$  mm) patch-repair panel with no plug. All impacted at 7.5 J: (a) load versus time traces and (b) load versus displacement traces.

The final study in this paper is to compare firstly the addition of a plug in the patch-repair panels versus the patch-repair panels without a plug, using the pristine panel as a baseline. All tests were conducted at an impact energy of 7.5 J. For this study, patches, with diameters of 55 and 65 mm, of half the thickness, 0.5 t, of 2.29 mm of the parent material were used. The load versus time, and load versus displacement, traces are shown in Fig. 16. These results reveal that the presence of a plug increases the stiffness and hence the load before damage initiation of the repaired panel occurs. On the other hand, thin patch-repairs of 0.5 t = 2.29 mm, for both the 55 and 65 mm diameter patches, with no plug present, result in the lowest, and least well defined, load drops at the initiation of damage in the repaired panels, i.e. of 1771 N and 1689 N, respectively. Further, a thin patch-repair (of thickness, 0.5 t, = 2.29 mm) panel, for both 55 and 65 mm diameter patches, with a plug present, results in the highest values of the peak loads of 7550 N (for the 55 mm patch) and 7880 N (for the 65 mm patch), and these designs of repair clearly provide very impact-resistant repaired panels. Secondly, a 65 mm diameter patch of thickness, t = 4.58 mm, with no plug present, results in a load drop which is well defined at 5249 N. The behaviour here is similar to that of the pristine panel with a load drop at 4693 N.
