The early impact of large wood introduction on the morphology and sediment characteristics of a lowland river

Nana A. Osei, Angela M. Gurnell, Gemma L. Harvey

ABSTRACT

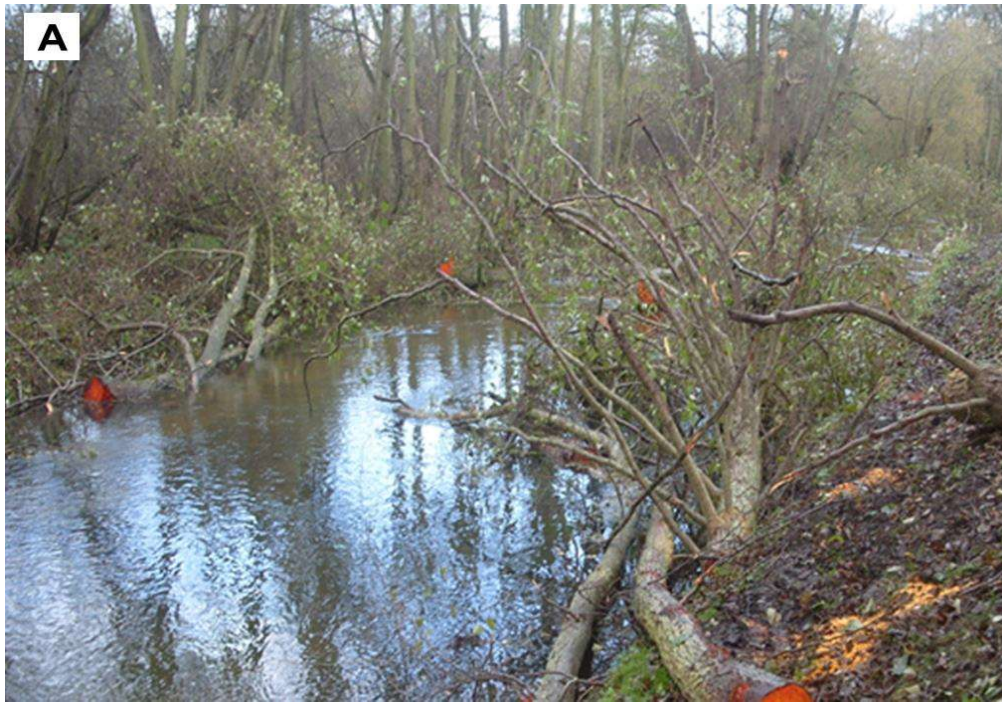
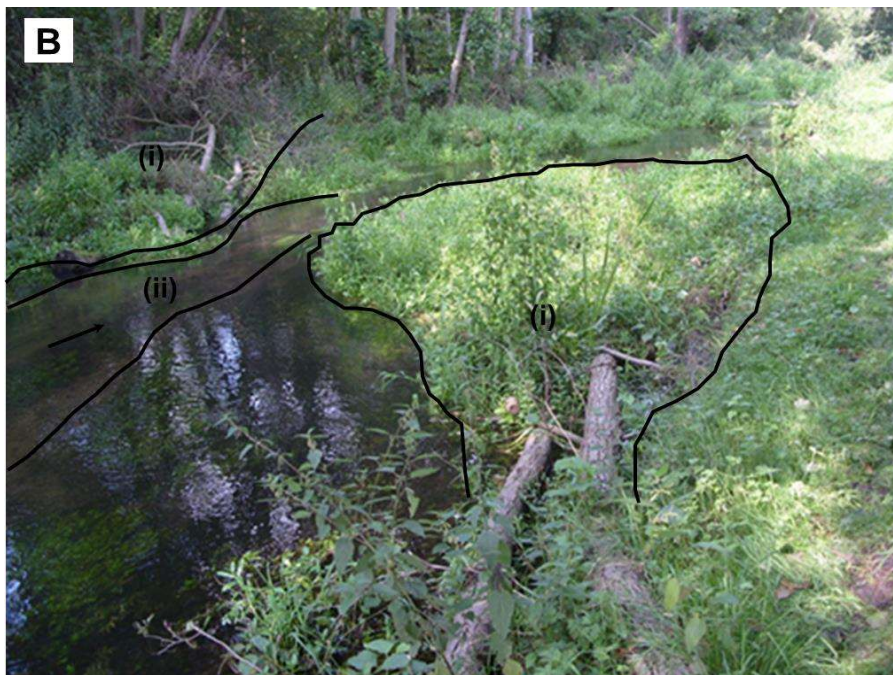
Figure 5. Fixed-point photographs of part of the study reach: (A) the introduced wood (09/11/2010) and (B) alterations in channel morphology and vegetation colonisation at the same location as A. (10/7/2012). The photograph indicates (i) vegetation within and around wood jam adjacent the floodplain, and (ii) exposed gravel bed in area of flow concentration between wood jams and associated vegetation.
